Desborough Conservation Area Appraisal Adopted 30th March 2007

Abstract

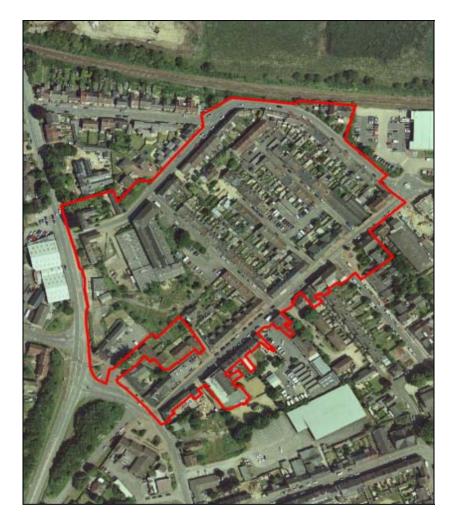
Figure 1: Aerial photograph (2005) showing adopted conservation area boundary

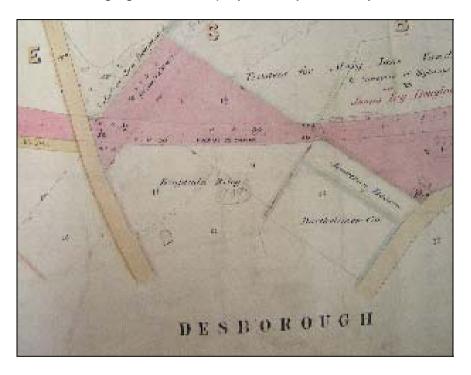
5.2.3 The Midland Railway, to the immediate north of the site was opened in 1857. The Midland Railway survey drawing opposite highlights the land under study as belonging to local employer, Benjamin Riley.

Figure 2: Extract from Midland Railway Survey

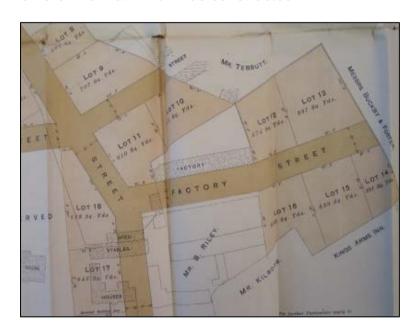
5.2.5 The map opposite shows the 'land laid out as building sites', and a proposed street alignment, which is different to that which was constructed.

Figure 3: Extract from plan showing proposed building plots

5.2.6 The map shows two rectilinear factory buildings on the west of the site. One building is outlined to be the

Benjamin Riley Boot and Shoe Company factory; the other is known to be the Nichols, Evans and Clow Boot and Shoe Company. It is evident that these buildings were the first buildings to be erected in the site, built on a featureless site, which imposed no restraints on their orientation.

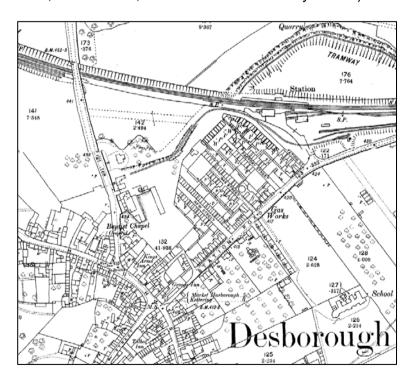
5.2.7 The OS plan of 1886 shows the new area of settlement to the north-east of the town (Station Road, New Street, Gas Street and Factory Street).

Figure 4: Extract from first edition OS (1886)

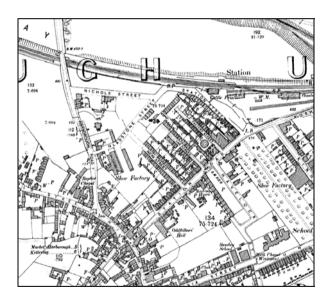
Figure 5: Extract from second edition OS (1900)

5.2.10 By 1900 an extension has been built on the eastern side of the western factory and it appears that the

ground between the two factories has been in-filled, as there are no 'cutting' marks where they were once evident. The central and southern parts of the site are indicated as being undeveloped at this time. Away from the site, extensive quarrying of ironstone can be seen in the fields to the north of the site, on the other side of the Midlands Railway.

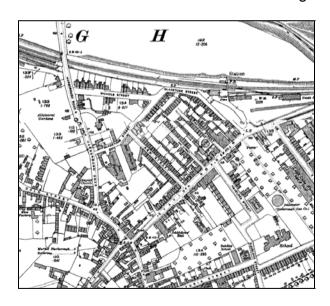
5.2.11 By 1926 further extension has occurred to the western factory and the Lawrence Boot Factory. A number of other outbuildings have been constructed across the site and a number of fences or walls have been built. The buildings in the southwest and northwest of the whole site remain unchanged.

Figure 6: Extract from third edition OS (1926)

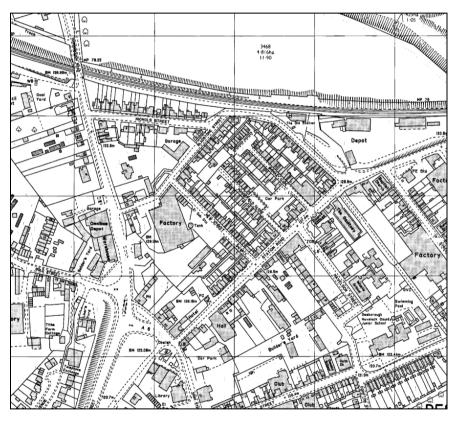
5.2.12 The large scale plan of 1970 shows the garage building in place with its large yard to the rear. It shows the original buildings in the southwest corner of the site still intact and it marks the Lawrence Factory as a 'Cut Sole' factory and the western factory as a 'Waste Reclamation' factory.

Figure 7: Extract from fifth edition OS (1972)

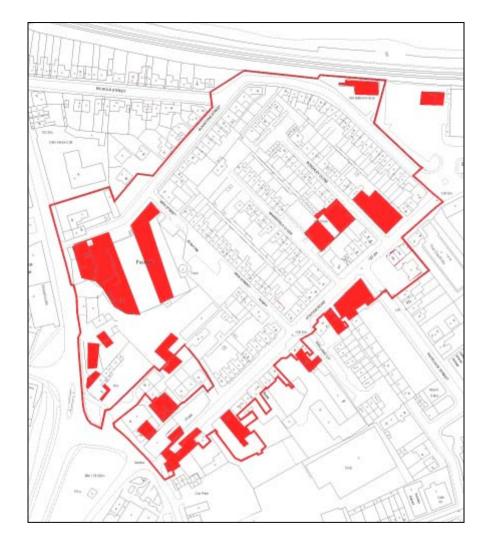
- 5.3.1 There are no Scheduled Ancient Monuments in the town of Desborough.
- 5.3.2 It was reported by Ballinger (2002) that there would appear to be little potential for below ground archaeological investigation for the industrial period in Desborough. Ballinger (2002) states that, 'buildings and monuments of the industrial period that have been demolished have largely been replaced by modern development'. However, this does not mean that there is not mean that there are no significant archaeological remains in the area. It is worth noting that there have been finds of archaeological importance within the town.
- 5.3.3 Details from the Northamptonshire Sites and Monuments Record have highlighted sites of likely archaeological significance within the area, as seen highlighted in figure 8 opposite.

Figure 8: Known and predicted sites of archaeological significance

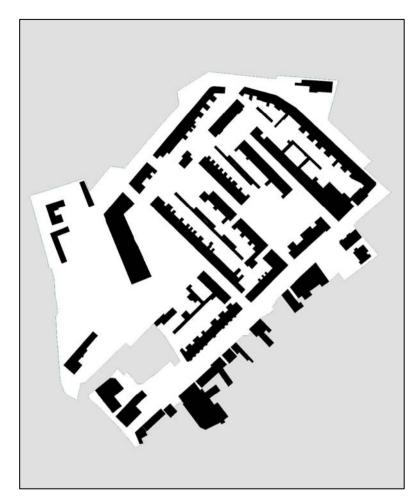
- 6.1.2 As highlighted by the figure-ground diagram opposite, the factory site to the west of the conservation area is separate and distinct from the dense worker housing to the east.

Figure 9: Figure-ground diagram

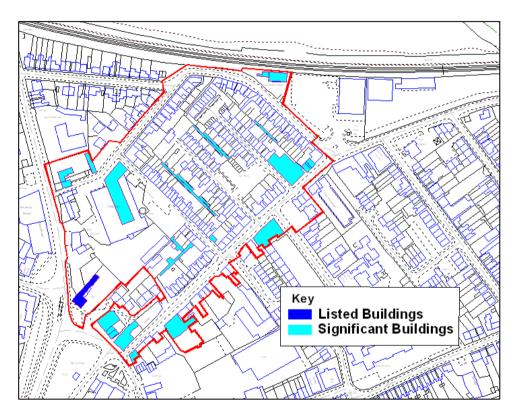
Figure 24: Listed and significant buildings

7.3.1 There is only one listed building within the defined area, however, it must be noted that there are several buildings of architectural or historic merit, as summarised below:

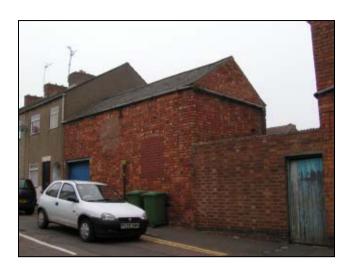
7.3.11 The small, rectilinear brick built building attached to no.1 New Street appears to have been built for the boot and shoe industry, although without further investigation it is difficult to assess its exact purpose.

Figure 25: Building attached to no. 1 New St

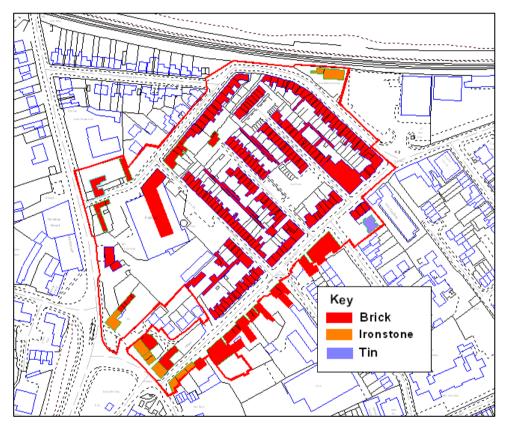
- 7.5.1 The principal building material of the area is red brick. However, south of the boundary where there are remnants from the historic core of the town, much of the building material is iron-stone. This can be seen in figure 26 opposite.
- 7.5.2 Historically, Welsh slate would have been used as a roofing material, with timber doors and windows. These have largely been replaced by concrete interlocking roof tiles and plastic alternatives to doors and windows respectively. A number of houses have also been rendered or clad.
- 7.5.3 Some low-key decoration is still evident to the stone lintels above doors and windows. Some of the terraces also have interesting string-course patterns between ground and first floor, and brick dog toothed corbelling under the eaves.

Figure 26: Building materials

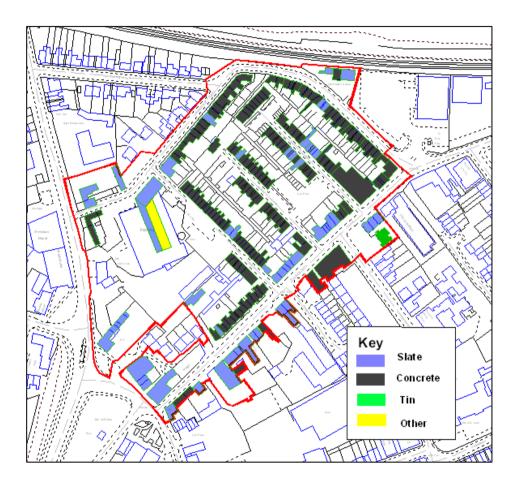
- 7.6.1 There are some elements which detract from the special character of the area.
- 7.6.2 The front facades of many houses have been rendered and clad this appears incongruous in the street scene. In addition, the vast majority of the terraced properties no longer have their original external joinery details and several have been replaced with uPVC. As seen on figure 22, opposite, the majority of the original slate roofs have been replaced with concrete tiles.

Figure 28: Roof-covering materials

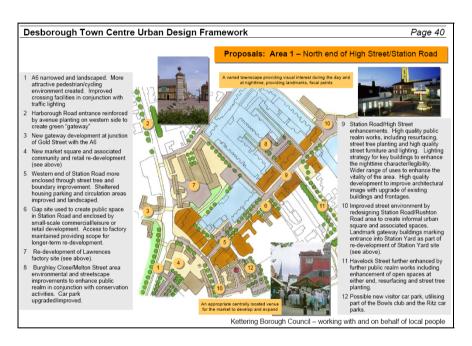
- 8.2 There are two key issues which are likely to have the greatest total impact on the future management of the conservation area:
- 8.3 <u>Desborough Urban Design Framework (UDF)</u>
- 8.4 The UDF for Desborough (2003) highlights the area within the proposed Conservation Area as 'Area 1'. The area is dominated by the Lawrences Factory Site (discussed below), but also proposes smaller schemes to support the heritage of the town centre. These include introducing high quality paving along

- the High Street, new street furniture and the lighting of strategic buildings. The UDF also proposes environmental improvement works to the Burghley Street/Melton Street car park.
- 8.5 It is considered that these projects are key elements of the management plan for the conservation area.

Figure 29: Extract from Desborough UDF

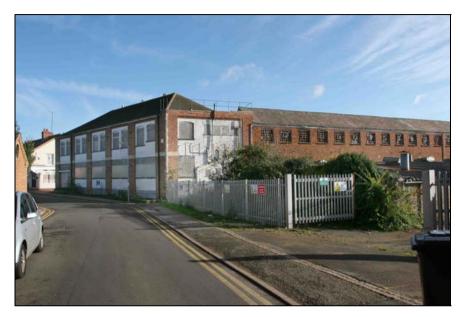
7.3.14 The former Lawrence's Boot and Shoe Factory has significant local heritage importance due to its links to the silk and boot and shoe industries. It is also worth noting that Northamptonshire County Council discovered it to be the longest remaining boot and shoe factory of its age in Northamptonshire.

Figure 30: Lawrence's Factory building
